MATERIALS RESEARCH FOR THE CLEAN UTILIZATION OF COAL

QUARTERLY PROGRESS REPORT

July - September 1980

Center for Materials Science
National Bureau of Standards
U. S. Department of Commerce
Washington, D. C. 20234

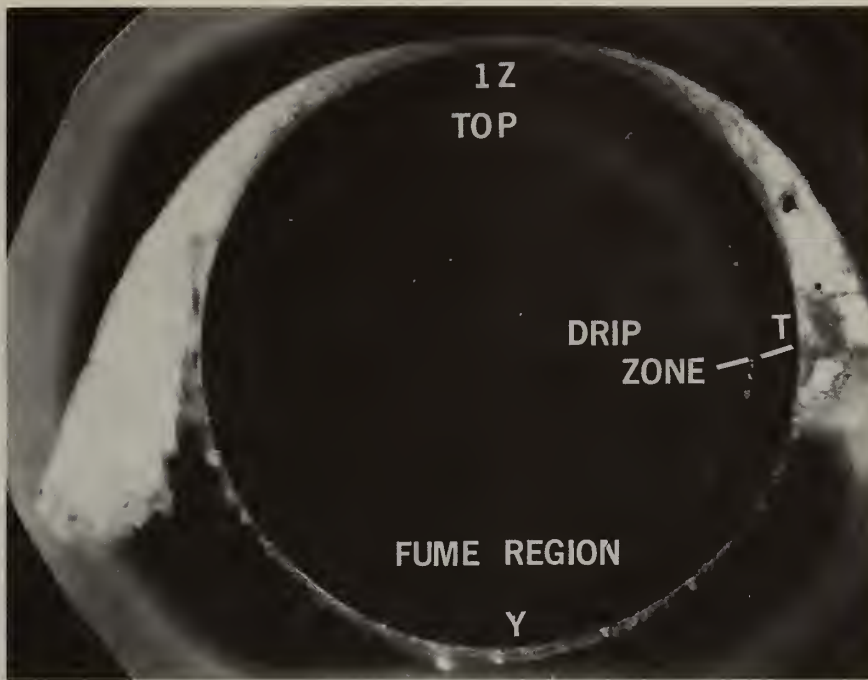
Fig. 1. Optical micrograph of a section of Type 316 stainless steel tubing after exposure to an oxygen rich hot gas stream seeded with K_2SO_4 and K_2CO_3 . Tube temperature $590^\circ C$. Note deposit on upper surface of tube.

An evaluation of specimens 8-6 (Figure 1) and 9-6 (Figure 24) can be made simultaneously. Both samples were seeded with 80% by weight K_2CO_3 and 20% by weight K_2SO_4 , with wall temperatures of 590 °C, however, 8-6 was in an oxygen rich fuel environment and 9-6 was in a fuel rich environment. The variations in the salt deposit can readily be observed with the oxygen rich specimen (8-6) exhibiting a top deposit of 0.3 mm, drip deposit of 2 mm and a slight fume deposit. The fuel rich specimen (9-6) shows a top coating of 0.1 mm, drip deposit of 1.6 mm and a very unusual fume deposit region, dendritic in nature. Photos (Figures 2 and 3) show a banding property in the deposit with K + S near the surface of the steel followed by a high K region with a thin band of K + S on the surface. This phenomenon is also seen in the

The corrosion process exhibited in both specimens seem to follow the same general corrosion mechanism. In sample 8-6 (oxygen rich) at the leading edge, salt-stainless interface (Figures 1, 4-12) we find the bulk stainless followed by a reaction zone area where high nickel is found with chromium and iron followed by an area of high chromium, high iron, nickel and potassium. Chromium and iron are then found penetrating the salt deposit with the iron being the most mobile species and moving far into the salt deposit. Nickel being the least mobile or least reactive species is generally not found to penetrate the salt deposit except at the interface where chromium and iron move rather readily through the salt.

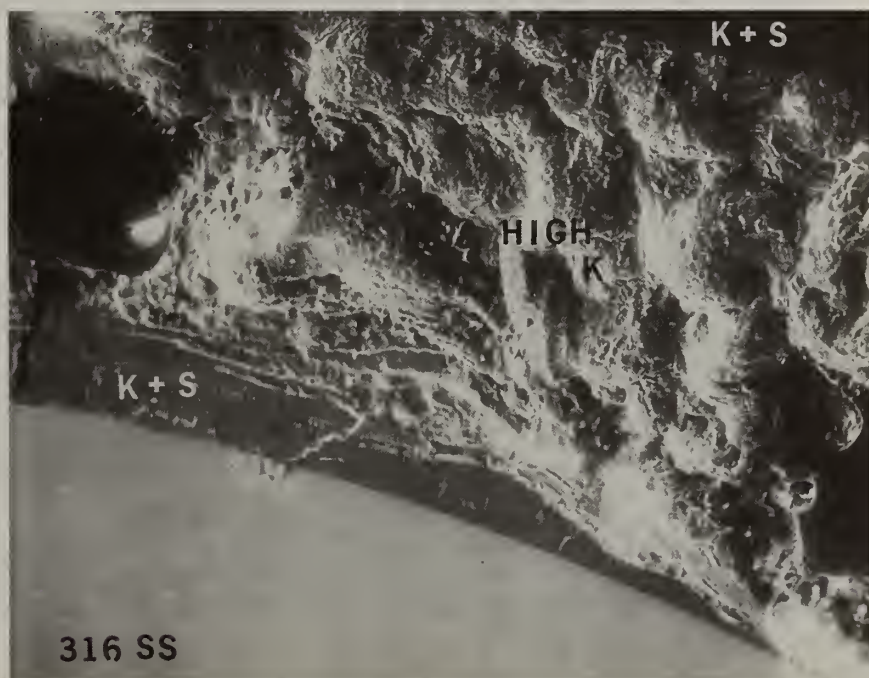
Fig. 2. SEM micrograph, 45 X, of region T of optical micrograph Fig. 1 showing metal-salt deposit interface in the drip zone.

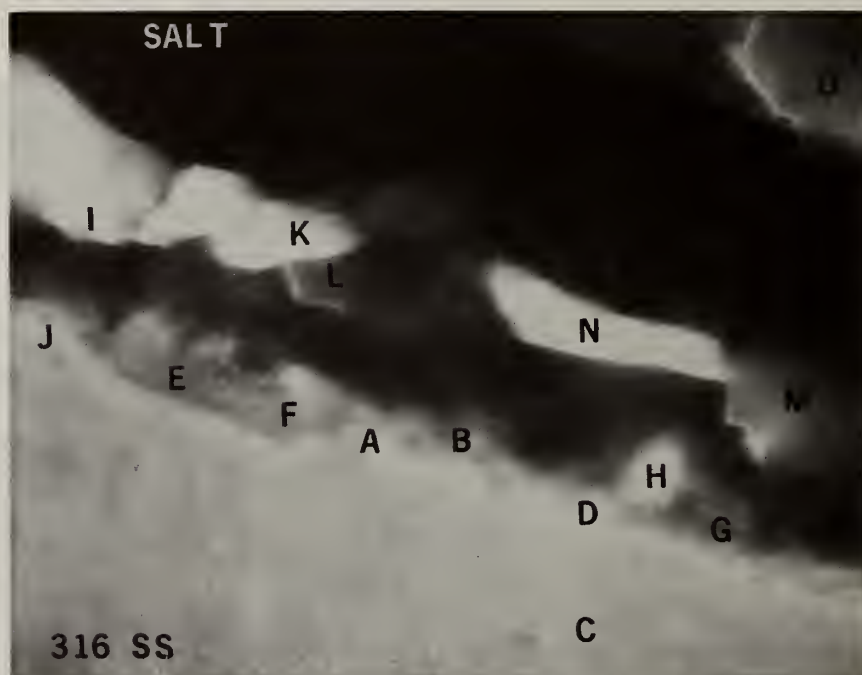
Fig. 4. SEM micrograph, 5460 X, of region 1Z of optical micrograph Fig. 1 showing reaction area at metal-salt interface. Lettered regions correspond to labeled EDX spectra Fig. 5-12.

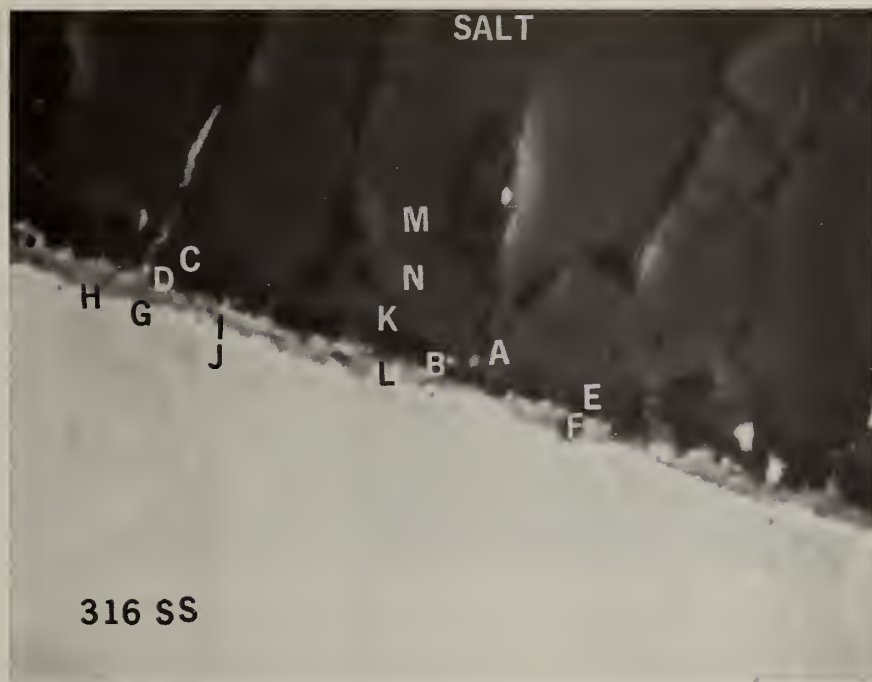
Fig. 13 SEM micrograph, 1800 X, of region T of optical micrograph Fig. 1 showing reaction area at drip zone (fume deposit-salt deposit-metal interface). Lettered regions correspond to labeled EDX spectra, Fig. 14-20.

In 8-6 (Figure 13), the corrosion or reaction zone can be seen at the drip zone salt deposit stainless steel interface region. This darker band region, as analyzed using EDX, Figures 13-20, shows high chromium, iron, low nickel, and potassium, indicating a reacted area on the metal surface. Analysis above and below this region again shows cation mobility. We find concentrations of the cations as follows: a) bulk stainless steel, b) higher nickel-chromium-iron, c) higher chromium-iron-nickel-potassium, d) chromium-high iron-potassium, e) iron-potassium, f) high potassium. Traces of sulfur are found in the coating and reaction areas, also, indicating some sulfur-cation reaction. Therefore, the SEM/EDX analysis seems to indicate a preferential leaching of the metal cations from the bulk materials (Type 316 stainless steel) in a somewhat orderly fashion as in the case of the 304 stainless steel. This can be corroborated by wastage (weight loss) experiments described in previous reports. The chromium and iron cations appear to be the more reactive species in the stainless steel and are preferentially leached by the potassium-sulfur salt. As these cations migrate from the bulk stainless steel composition to the salt deposit the relatively non-reactive nickel is left and what appears as layering is observed.

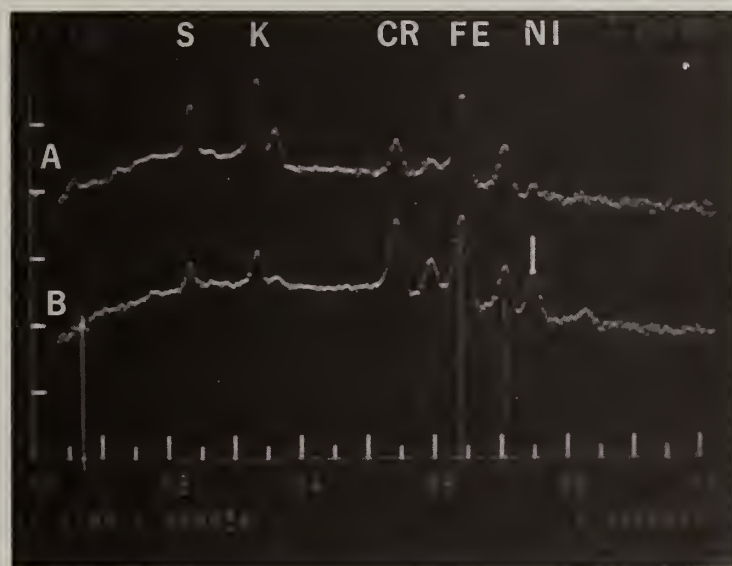
Fig. 14. EDX spectra of regions A and B of Fig. 13 showing high Cr concentration.

Fig. 15. EDX spectra of regions C and D of Fig. 13 showing high Cr concentration.

Fig. 16. EDX spectra of regions E and F of Fig. 13 showing high Cr concentration.

Fig. 17. EDX spectra of regions G and H of Fig. 13 showing high concentrations of both Ni and Cr.

Fig. 18. EDX spectra of regions I and J of Fig. 13 showing high concentrations of both Ni and Cr.

Fig. 19. EDX spectra of regions K and L of Fig. 13 showing high concentrations of both Ni and Cr.

Fig. 20. EDX spectra of regions M and N of Fig. 13 showing high S and K and a trace of Fe.

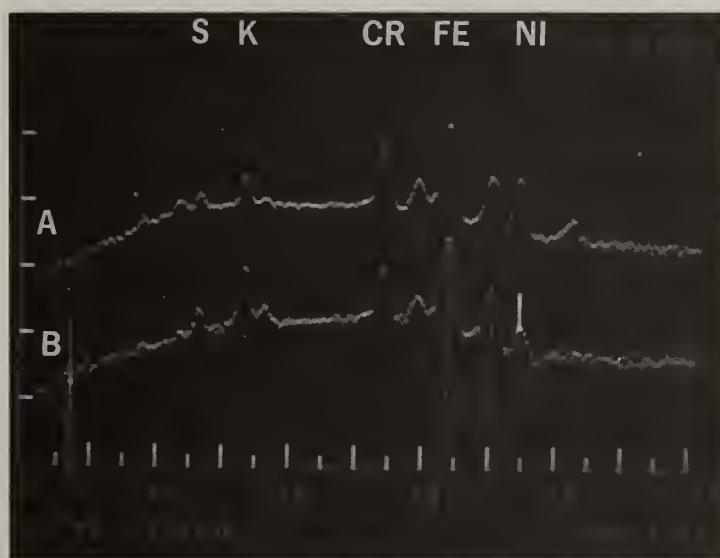
Fig. 22. EDX spectra of regions A and B of Fig. 21 showing high Cr concentrations.

Fig. 23. EDX spectra of regions C and D of Fig. 21 showing absence of Ni.

Figures 21-23 shows a portion of the fume deposit region where the corrosive process appears to be evident. On the edge, areas of low nickel are found, while areas of chromium, iron, potassium, and sulfur are found in the reaction zone. However, in the fume deposit region there is not as great a separation of the cations, as found by EDX, possibly due to the fact that no direct contact of the salt is made in this area during deposit but rather collected on the underside by condensation from the vapor.

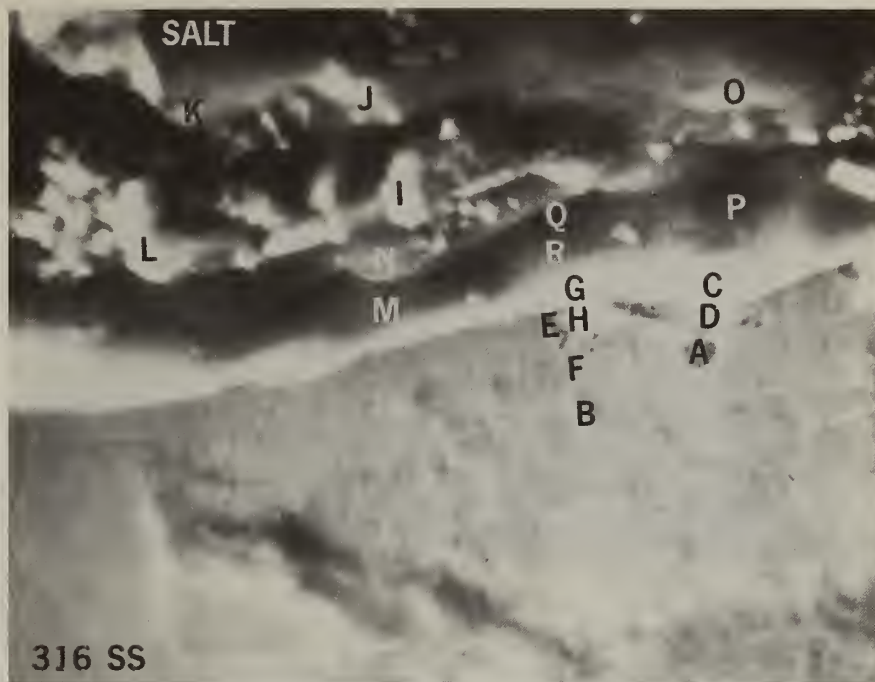
Fig. 25. SEM micrograph, 1720 X, of region 2Z of optical micrograph Fig. 24. Lettered regions correspond to labeled EDX spectra Fig. 26-34.

In sample 9-6, fuel rich, at the leading edge of the stainless steel (Figures 24-34) we again find the bulk stainless steel followed by a reaction zone area. As in the fuel rich sample (8-6), what appears to be a distinctive corrosion banding appears using EDX analysis. The corrosive process in the oxygen rich fuel environment

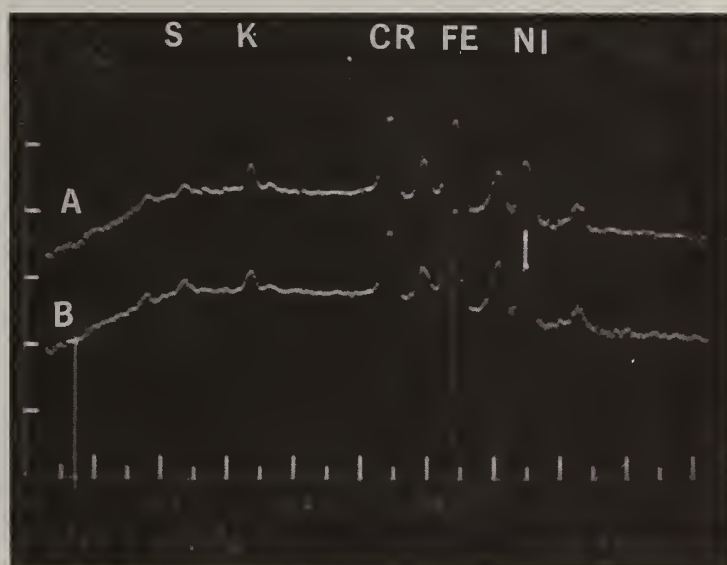
Fig. 26. EDX spectra of regions A and B of Fig. 25 showing high Cr and Ni concentrations.

Fig. 27. EDX spectra of regions C and D of Fig. 25 showing high Cr and Ni concentrations.

Fig. 28. EDX spectra of regions E and F of Fig. 25 showing high Cr concentrations.

Fig. 29. EDX spectra of regions G and H of Fig. 25 showing high Cr concentrations.

Fig. 30. EDX spectra of regions I and J of Fig. 25 showing high Fe concentrations.

Fig. 31. EDX spectra of regions K and L of Fig. 25 showing high Fe concentrations.

Fig. 32. EDX spectra of regions M and N of Fig. 25 showing Fe.

Fig. 33. EDX spectra of regions O and P of Fig. 25 showing trace of Fe in the salt deposit.

Fig. 34. EDX spectra of regions Q and R of Fig. 25 showing trace of Fe in the salt deposit.

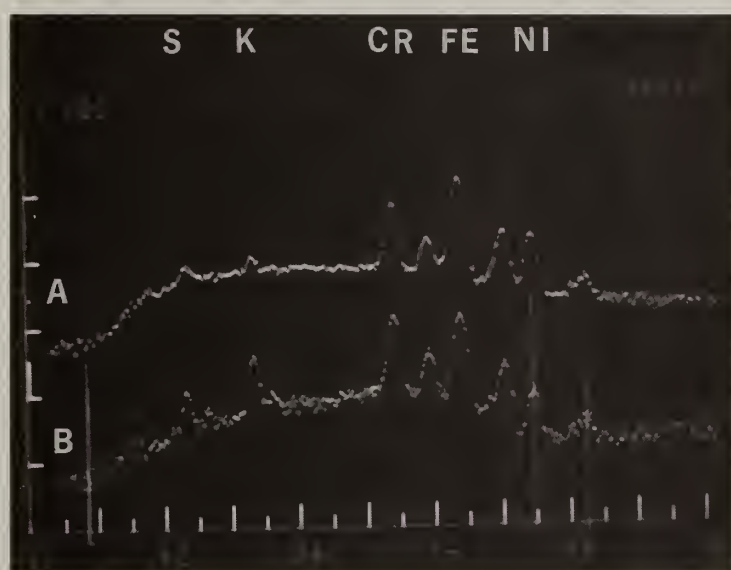
Fig. 46. EDX spectra of regions A and B of Fig. 45 showing high Cr and low Ni concentrations.

Fig. 47. EDX spectra of regions C and D of Fig. 45 showing high Cr and no Ni.

Fig. 48. EDX spectra of regions E and F of Fig. 45 showing high concentrations of Fe with a slight trace of Cr.

Fig. 49. EDX spectra of regions G and H of Fig. 45 showing Fe with a trace of Cr.

At a lower temperature of 500 °C, corrosion is still observed in Type 316 stainless steel, 5-6, using K_2SO_4 salt in a fuel rich environment. Figures 44-49 shows the reaction zone area at the metal-salt interface at the leading edge. In this area we find, using SEM/EDX: a) bulk stainless steel, b) low nickel-high chromium-iron-potassium-sulfur, c) potassium-iron-chromium-sulfur, d) potassium-iron-sulfur, e) potassium-sulfur. An area of high nickel is not detected while areas of high chromium and iron are readily discernible in the reaction zone. This corrosion mechanism is also found in the drip zone area and the fume deposit region, though both to a lesser degree.
